## Complete Photographs

**AREA053** TOMAKOMAI  
Completion :September 2017

**DHXL**  
DAYTONA HOUSE × LDK

**2-SPANS** GLB-regular garage version

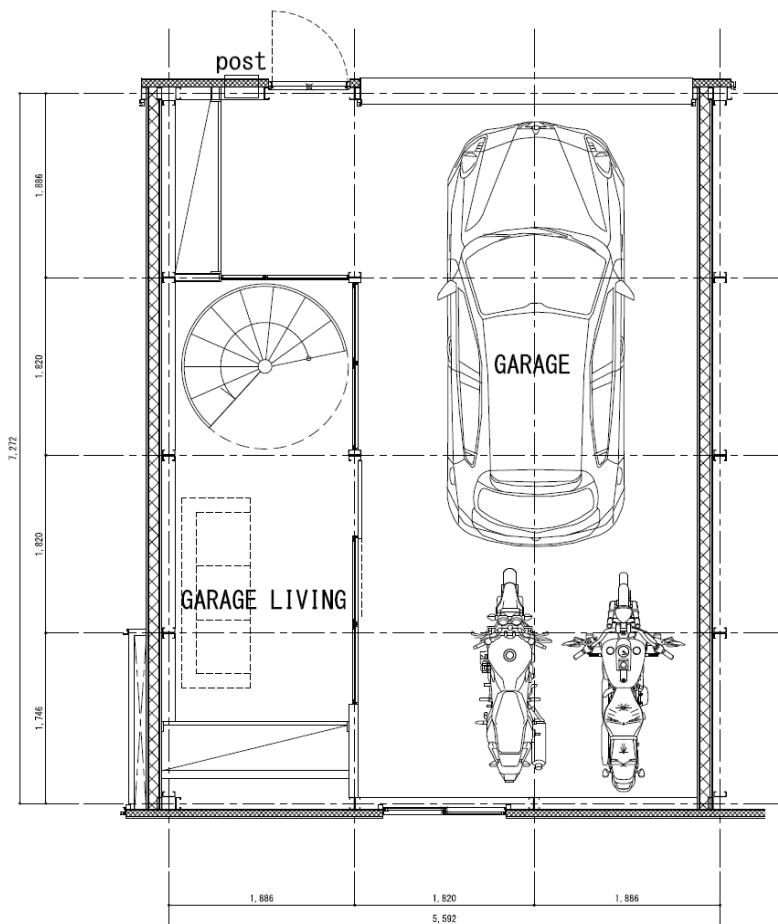
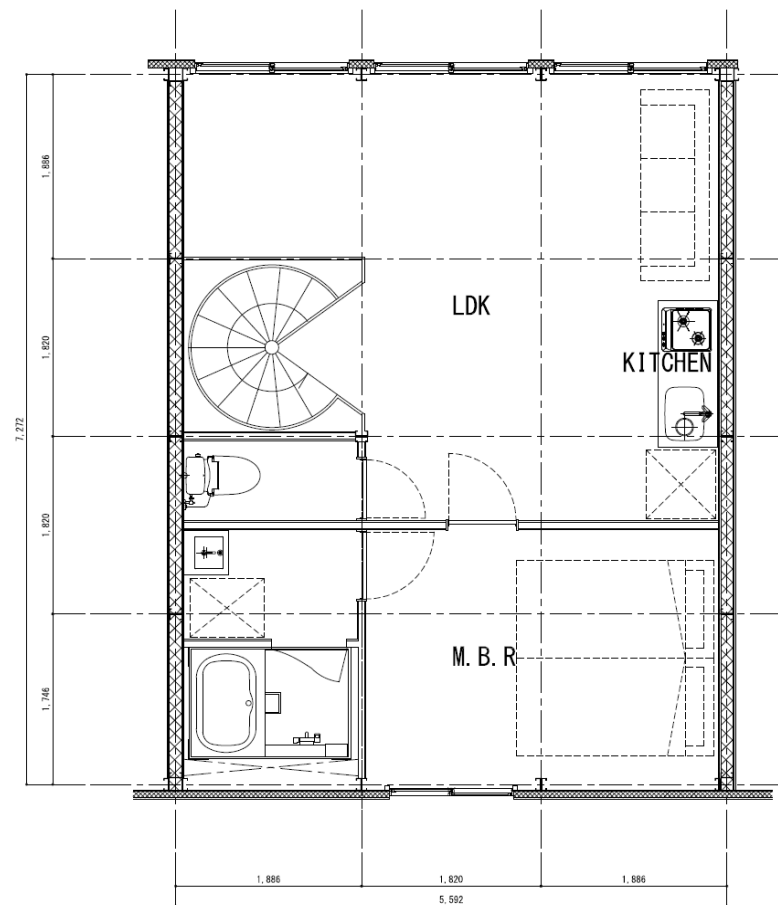
界壁 (1F)  
GW充填の上PB12.5+ガルバリウム鋼板t=0.9 (両面) 貼り  
(準耐火構造、遮音構造 告示1827号)

界壁 (2F)  
GW充填の上PB12.5+12.5 (両面) 貼り  
(準耐火構造、遮音構造 告示1827号)

界壁 (1F)

GW充填の上PB12.5+ガルバリウム鋼板 $t=0.9$  (両面) 貼り  
(準耐火構造、遮音構造 告示1827号)

界壁 (2F)

GW充填の上PB12.5+12.5 (両面) 貼り  
(準耐火構造、遮音構造 告示1827号)

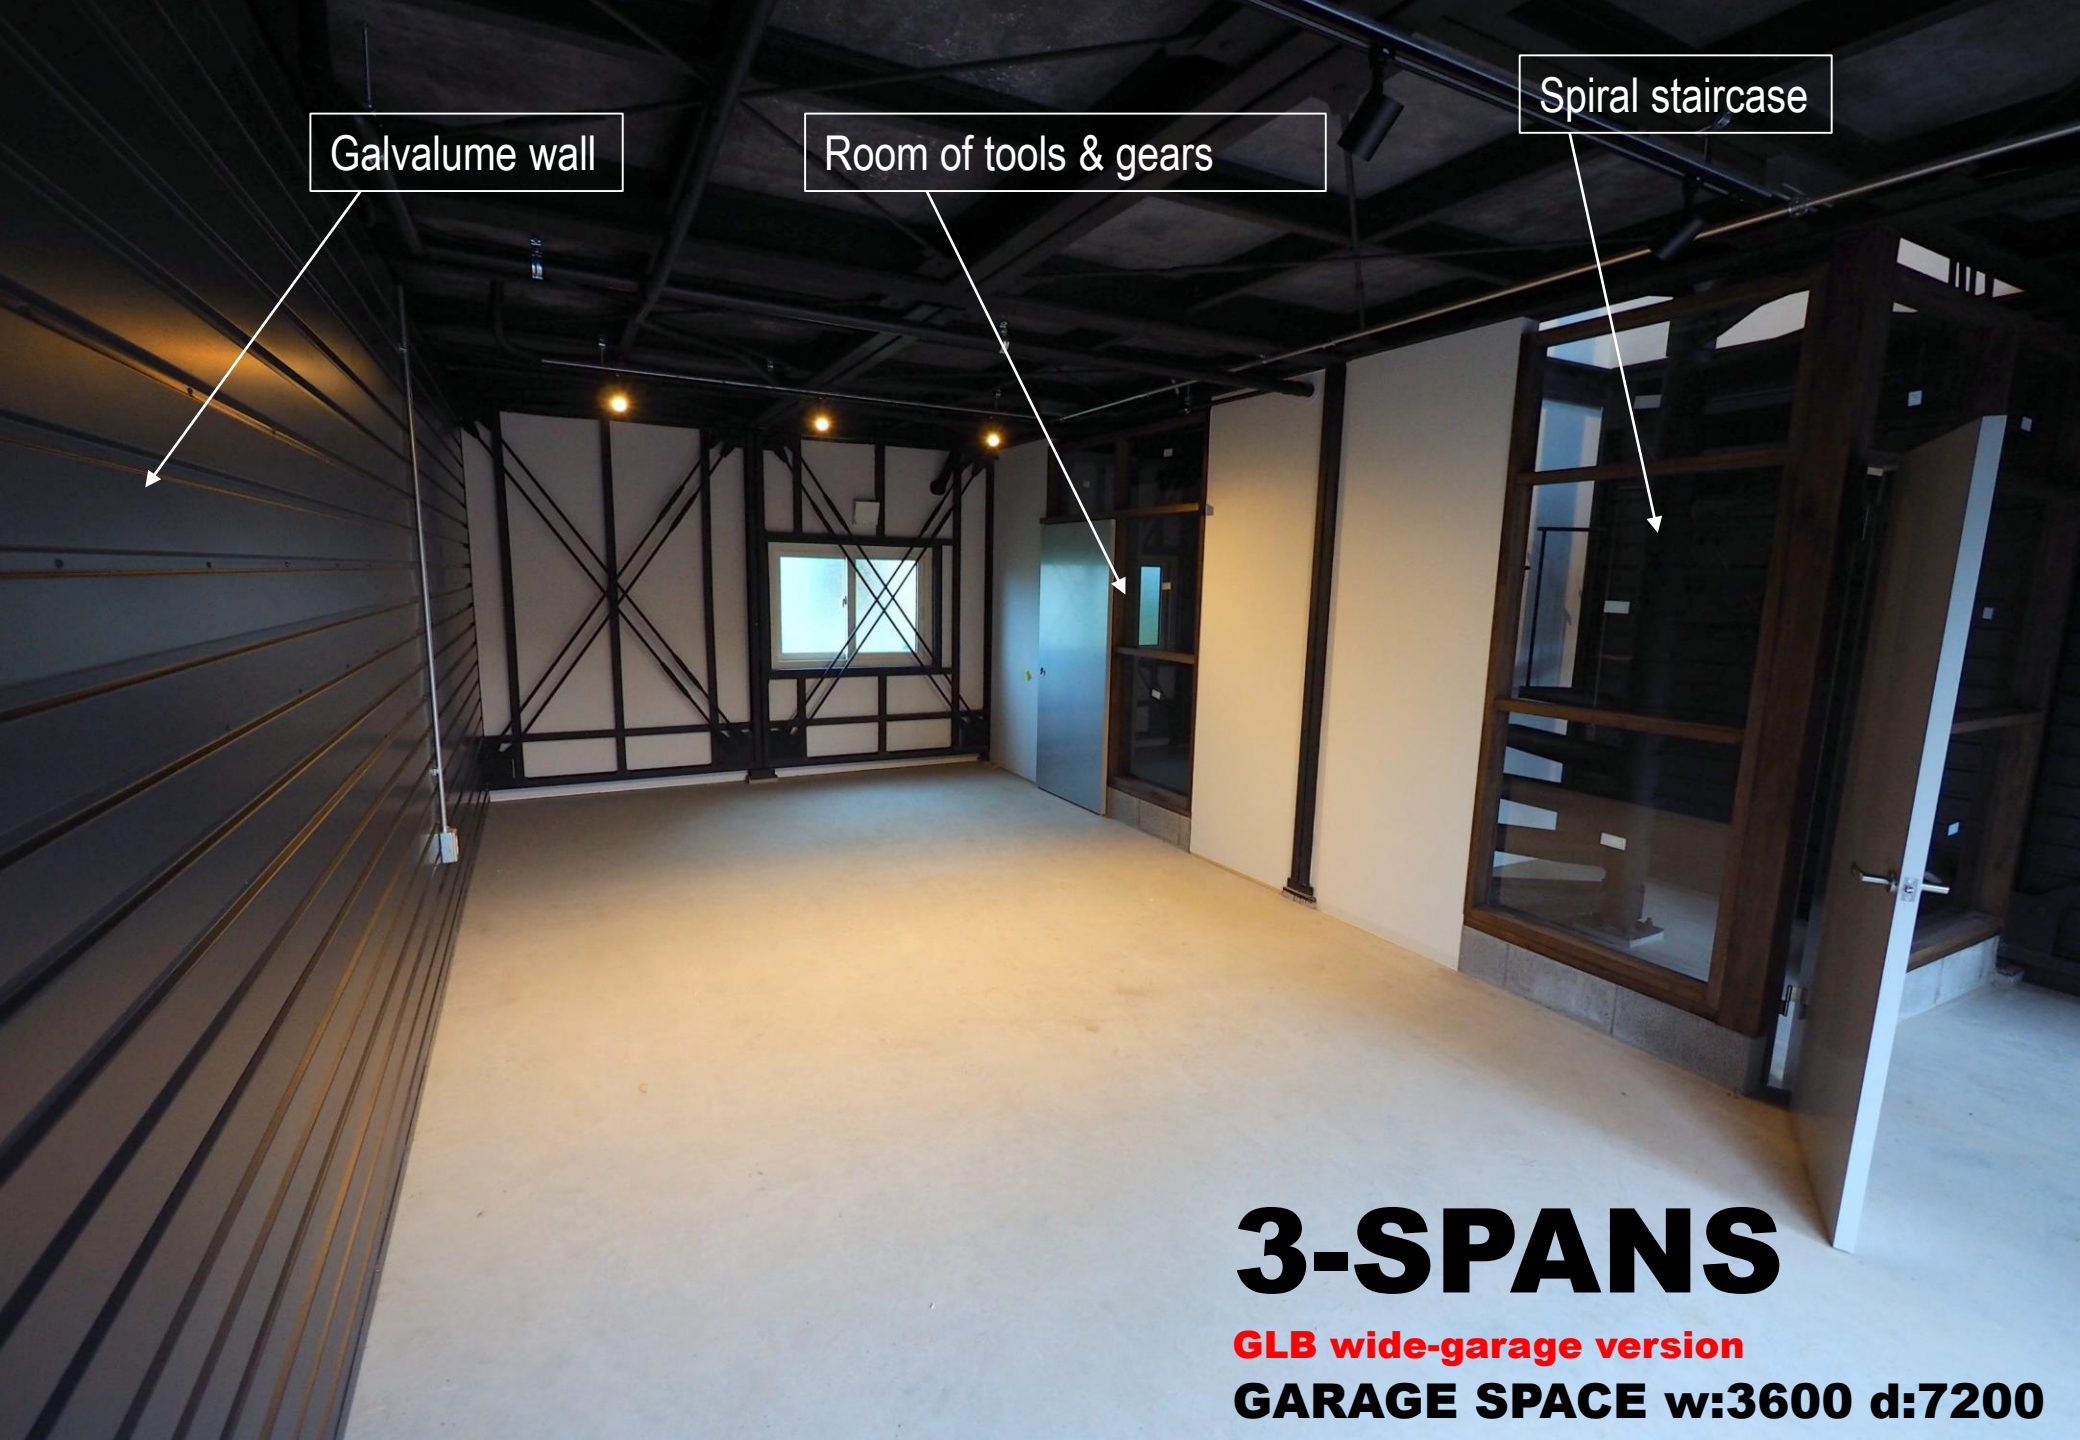
Galvalume wall

The image shows the interior of a modern garage. On the left, there is a long wall made of galvalume panels. The floor is a smooth, light-colored concrete. In the background, there is a room with a window and a door, labeled as the 'Room of tools & gears'. To the right, a wooden-framed glass door leads to a spiral staircase. The ceiling is dark with exposed beams and track lighting. Arrows point from the text labels to their respective features in the image.

Room of tools & gears

Spiral staircase

**GARAGE SPACE w:3600 d:7200**

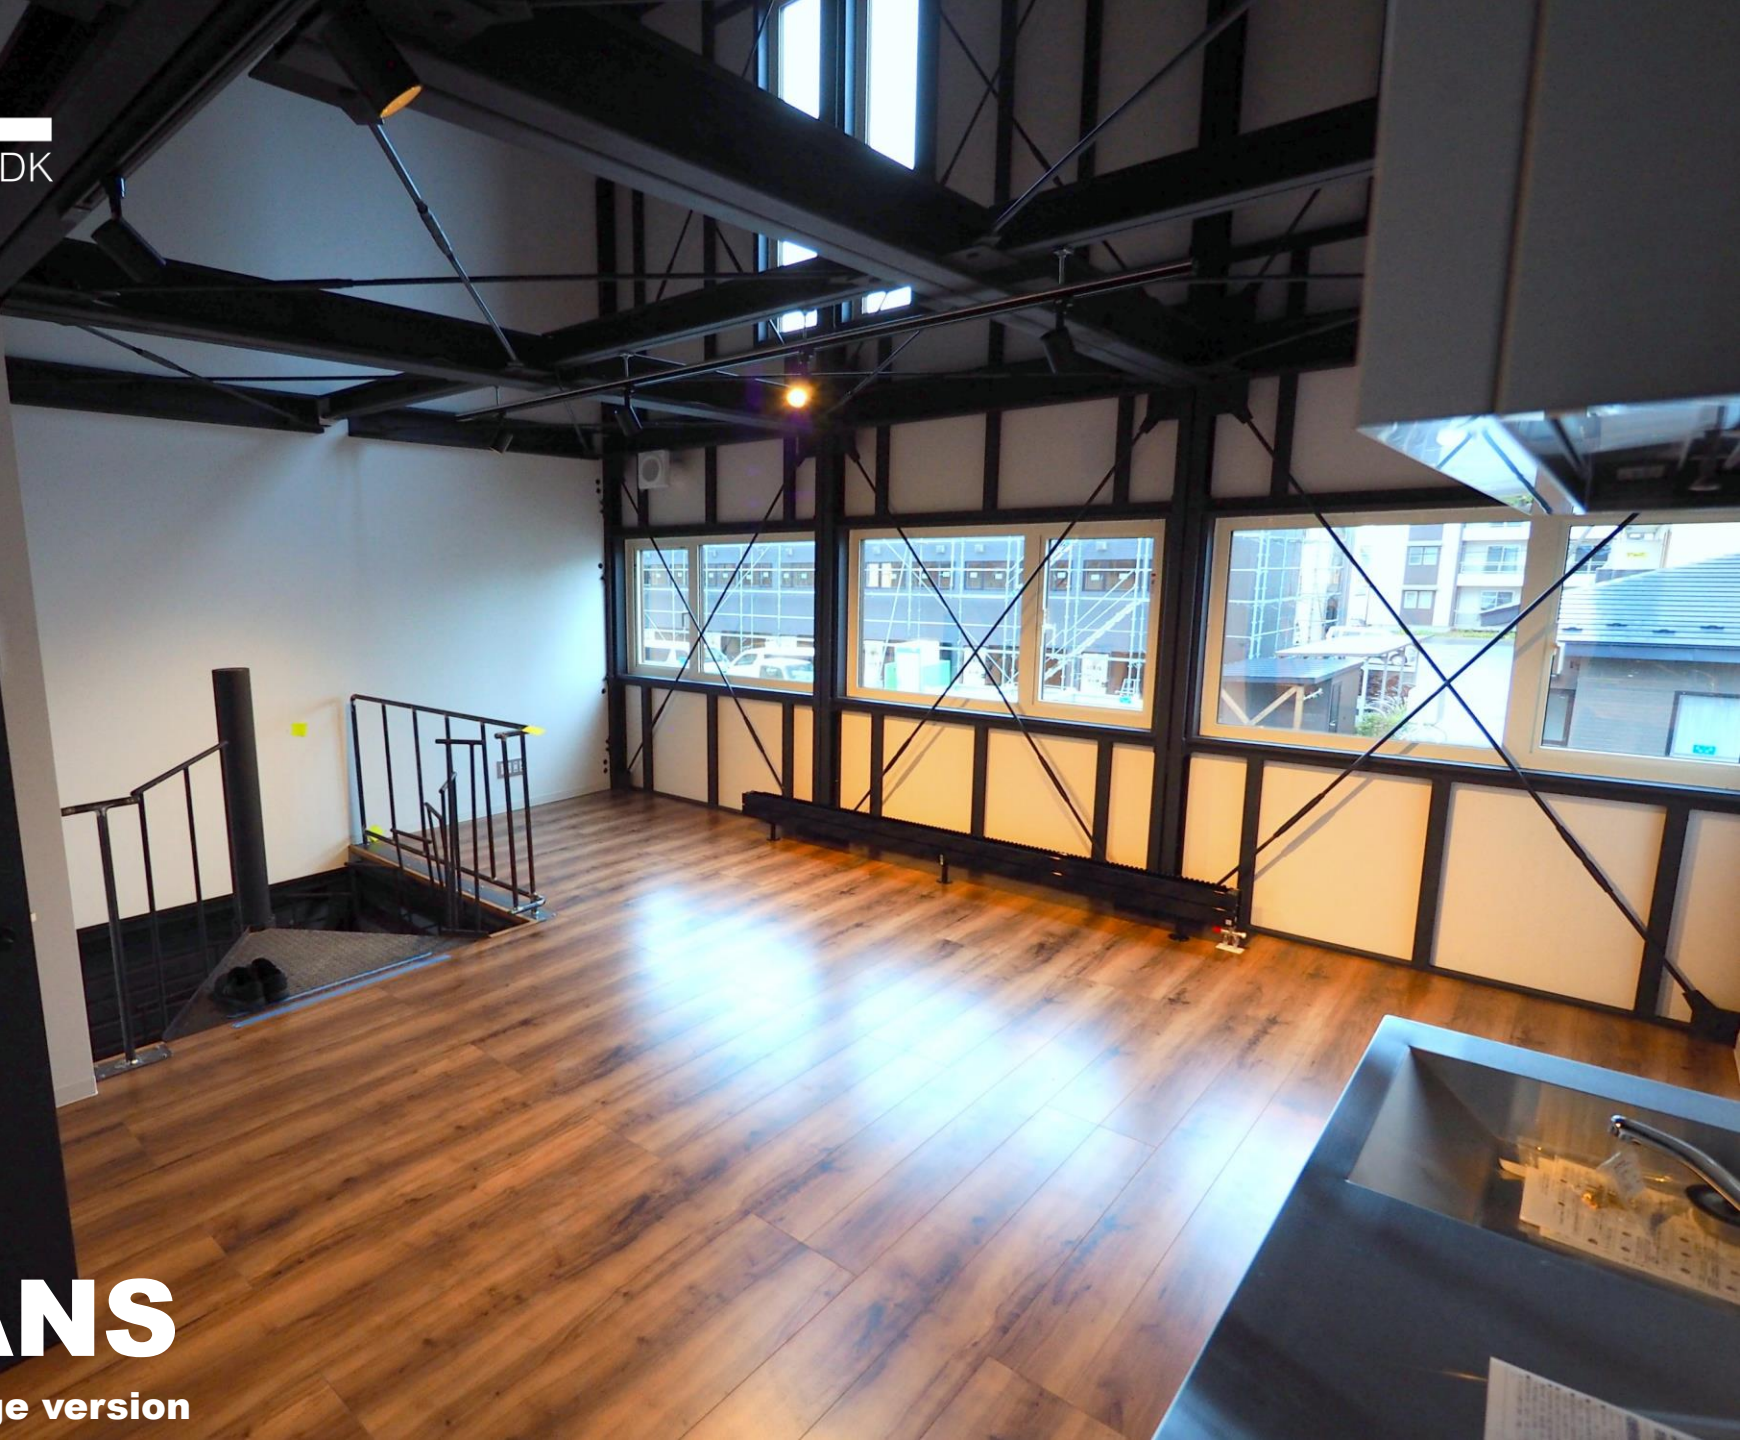
Loft / Bedspace

Spiral staircase
